Appendix 6

Photo Log

MS4 Mapping Discrepancies – City Operations Facility at Spa Road

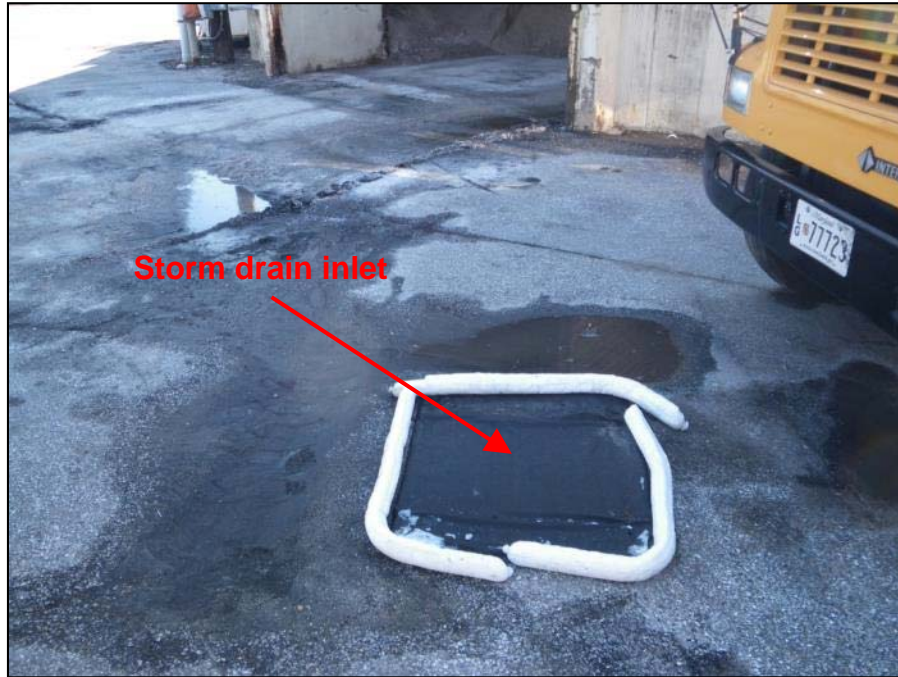
Photograph 1. View of storm drain inlet at the City's Spa Road Maintenance Facility that was not depicted in the City's GIS.

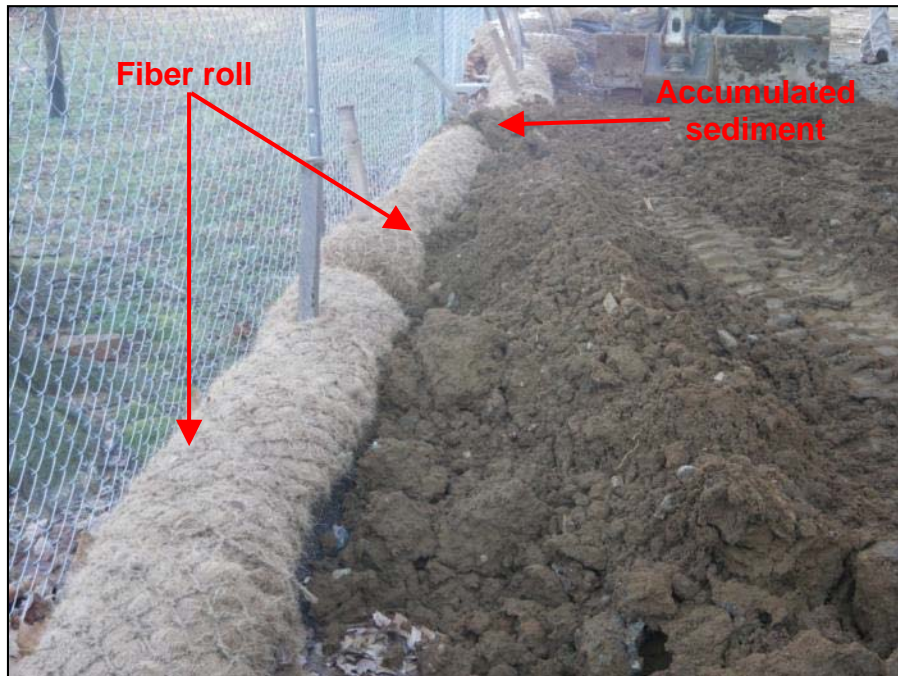
Photograph 6. View fiber roll BMP along northwestern edge of the site. Note area of fiber roll on which sediment had accumulated to a height greater than one half the height of the fiber roll.

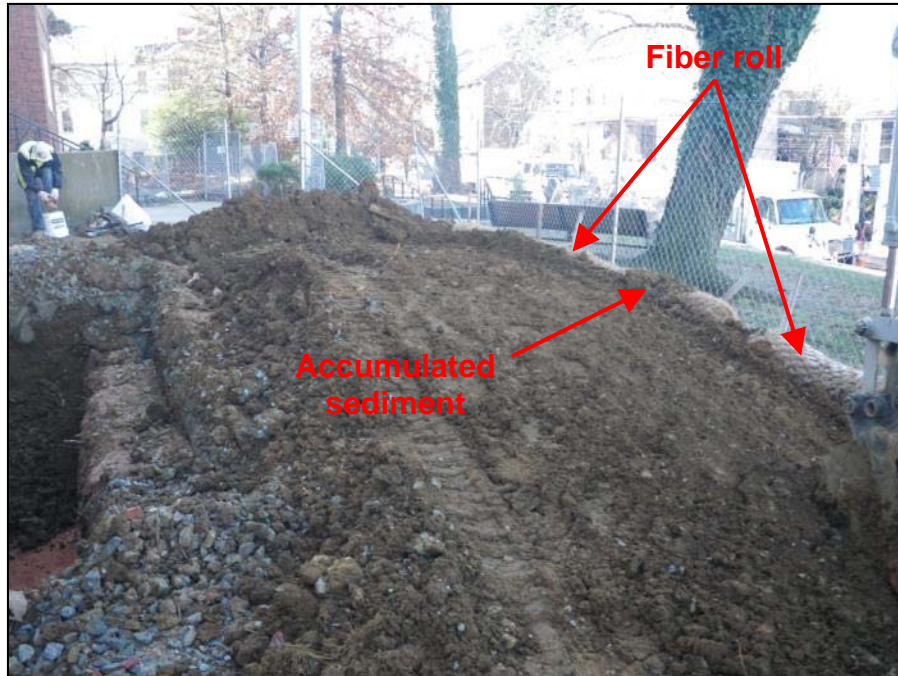
Photograph 7. Additional view of disturbed area and fiber roll BMP with accumulated sediment.

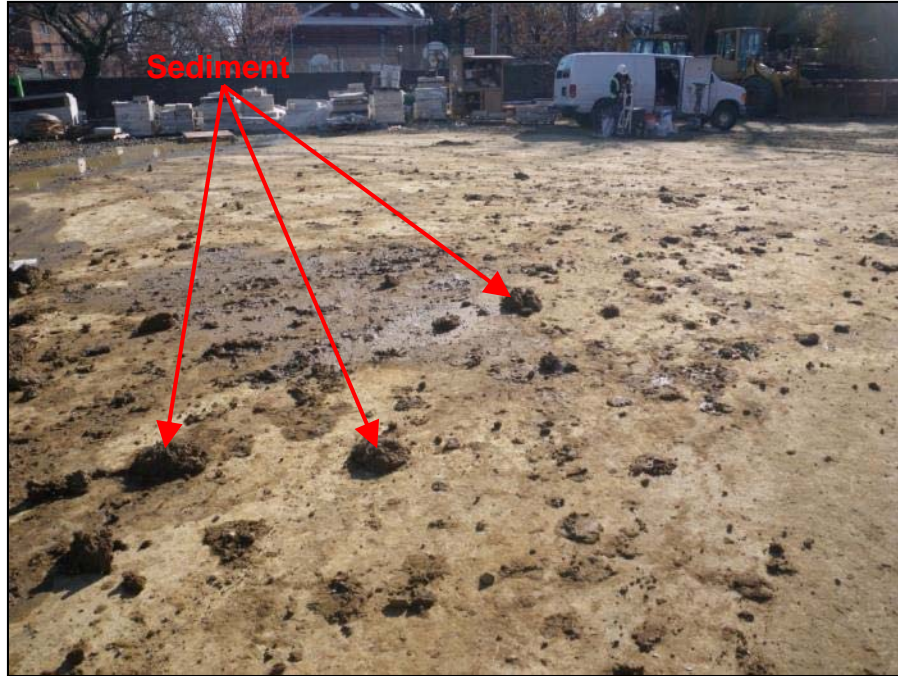
Photograph 9. View of sediment from vehicle tracking present on the impervious ground surface on the interior of the site, upgradient of the main construction site entrance.

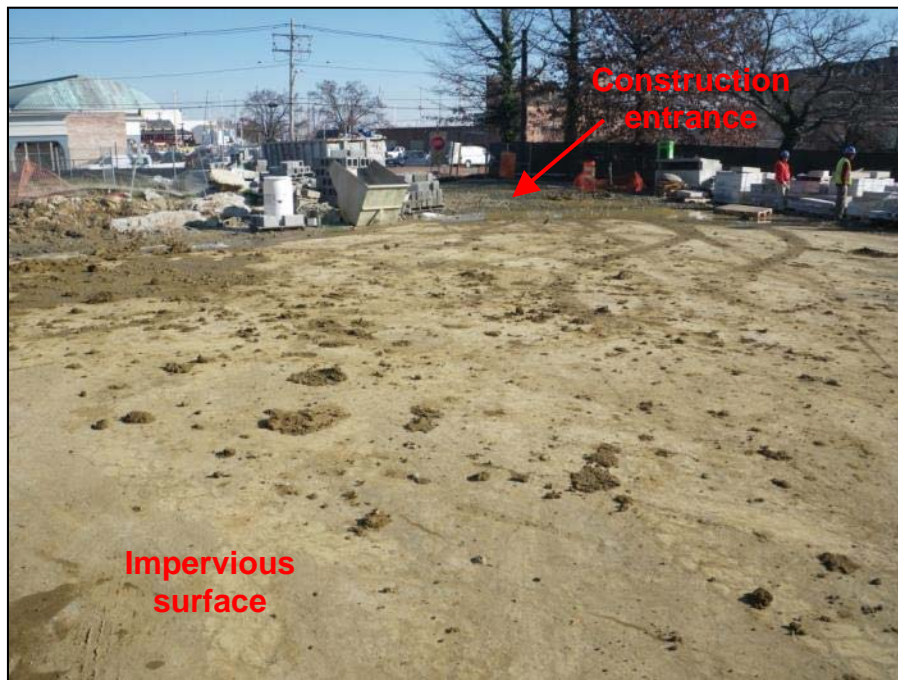
Photograph 10. Additional view of sediment from vehicle tracking present on the impervious ground surface on the interior of the site, upgradient of the main construction site entrance.

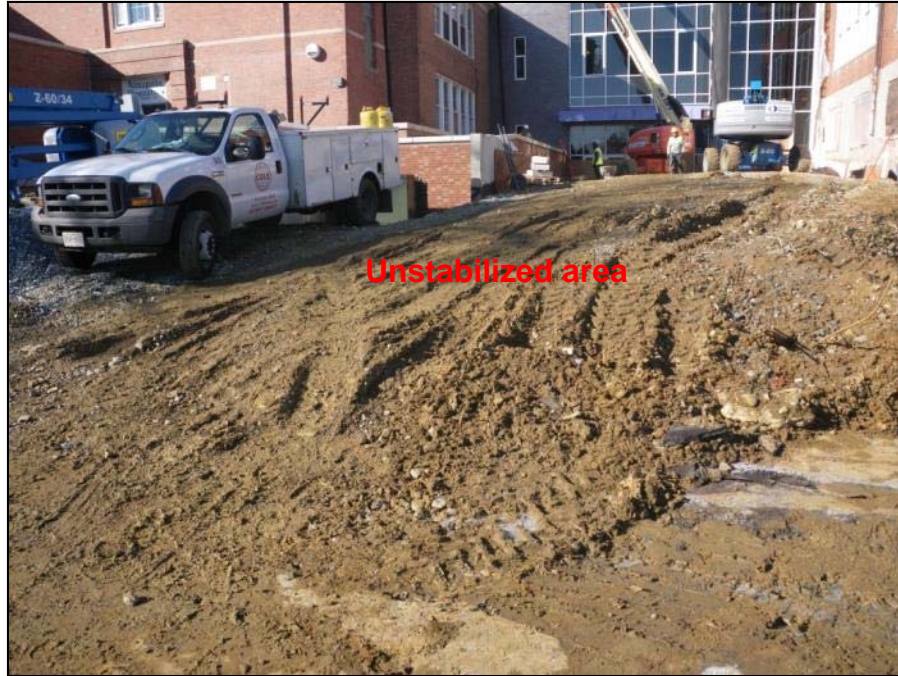
Photograph 11. View of unstabilized area upgradient of the interior impervious area shown in previous photographs which was being used for vehicle and equipment access at the time of the site visit.

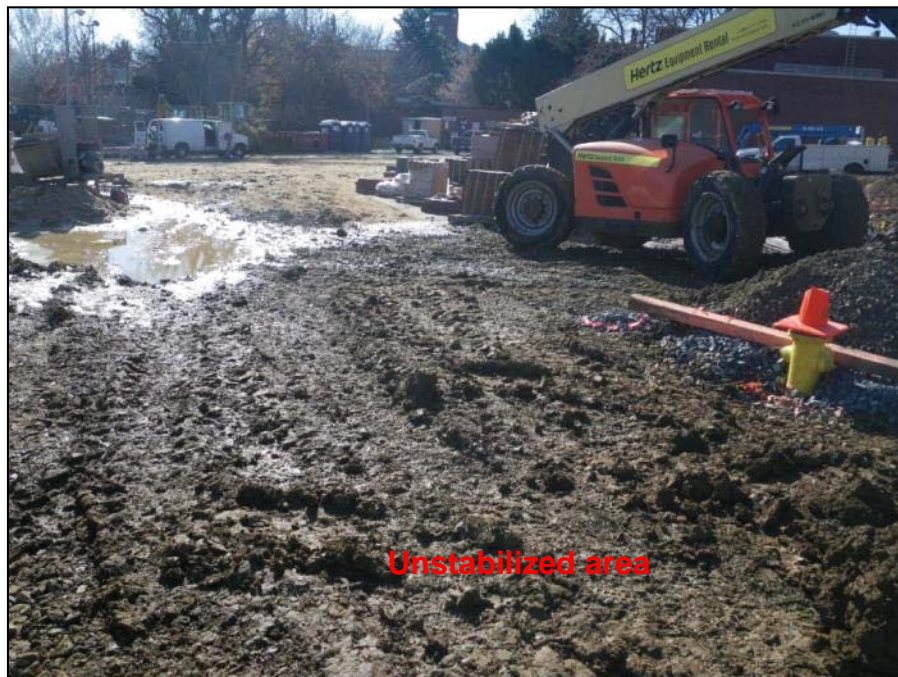
Photograph 12. View of view of additional unstabilized area being used for vehicle and equipment access at the time of the site visit.

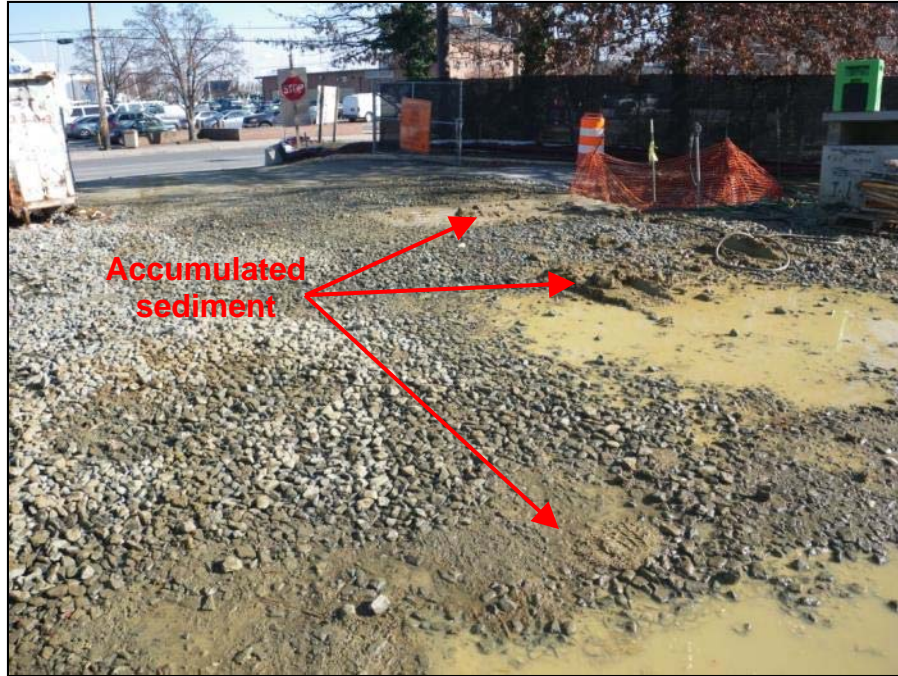
Photograph 13. View of accumulated sediment within the rock-lined construction entrance.

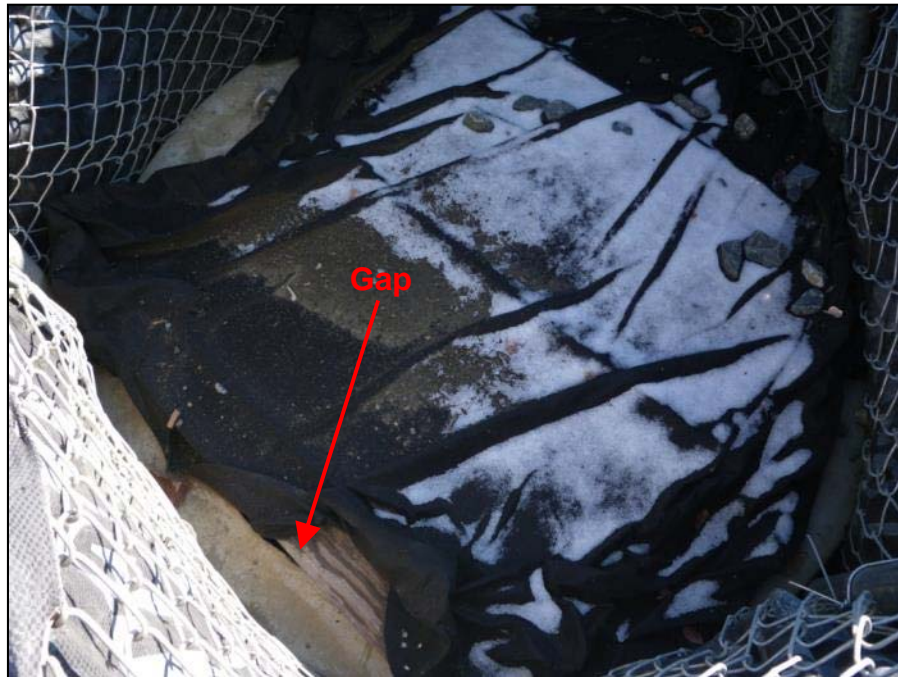
Photograph 16. Closer view of filter fabric installed on a storm drain inlet approximately 100 feet to the northwest of the construction entrance. Note that the filter fabric did not entirely cover the storm drain inlet.

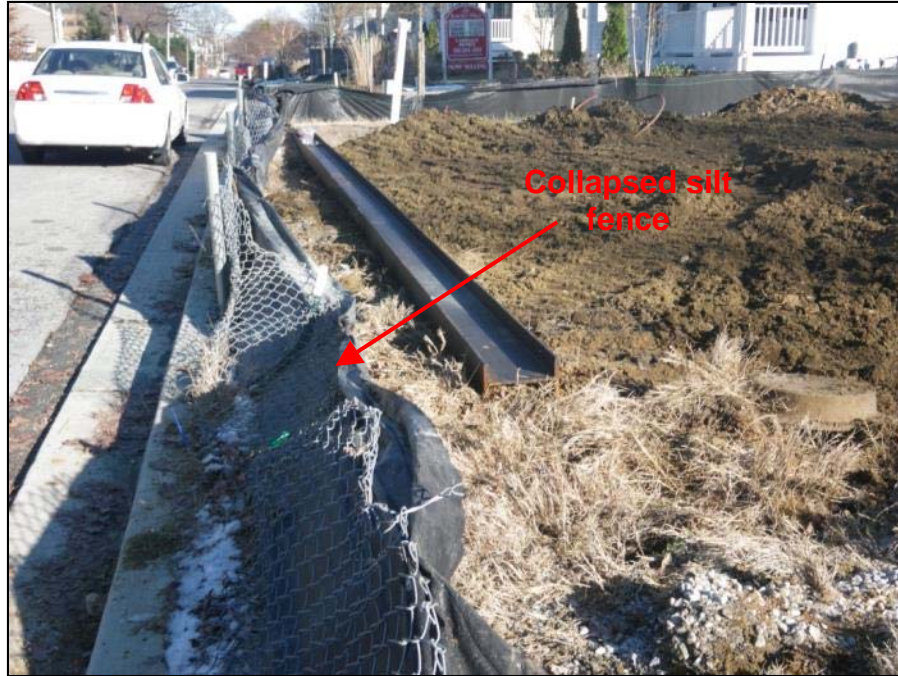
Photograph 19. Additional view of the collapsed silt fence along the northern perimeter of the site.

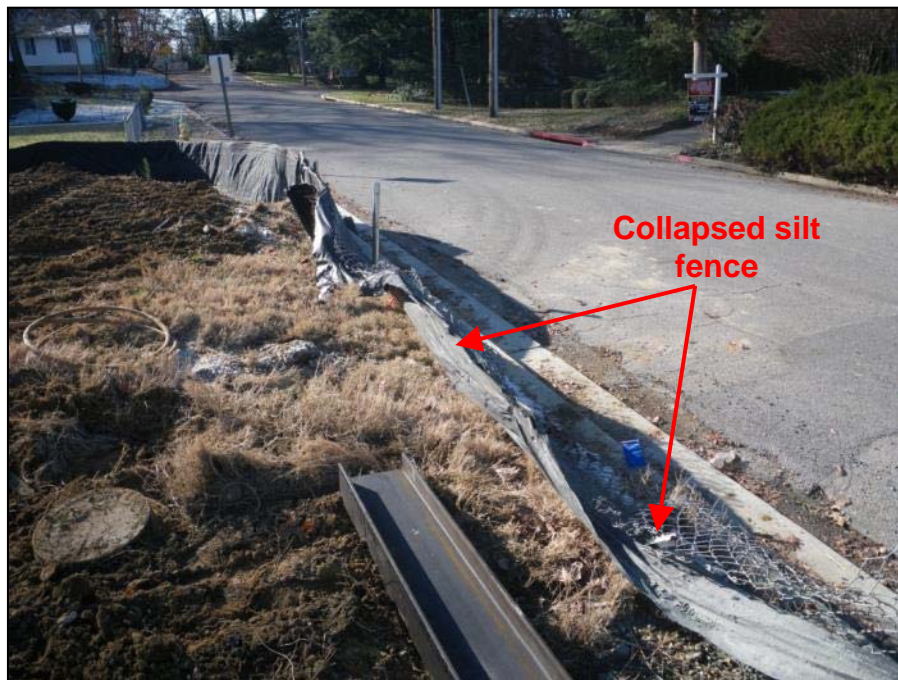
Photograph 20. Additional view of the collapsed silt fence along the northern perimeter of the site.

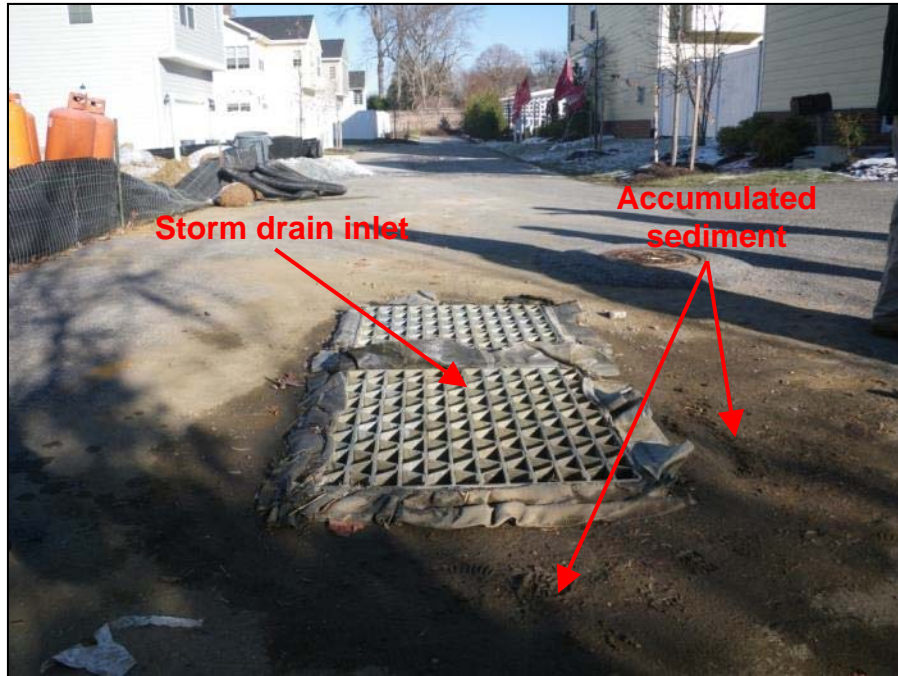
Photograph 21. View of accumulated sediment present around storm drain inlet equipped with filter fabric for inlet protection in the alley along the southeastern perimeter of the lot.

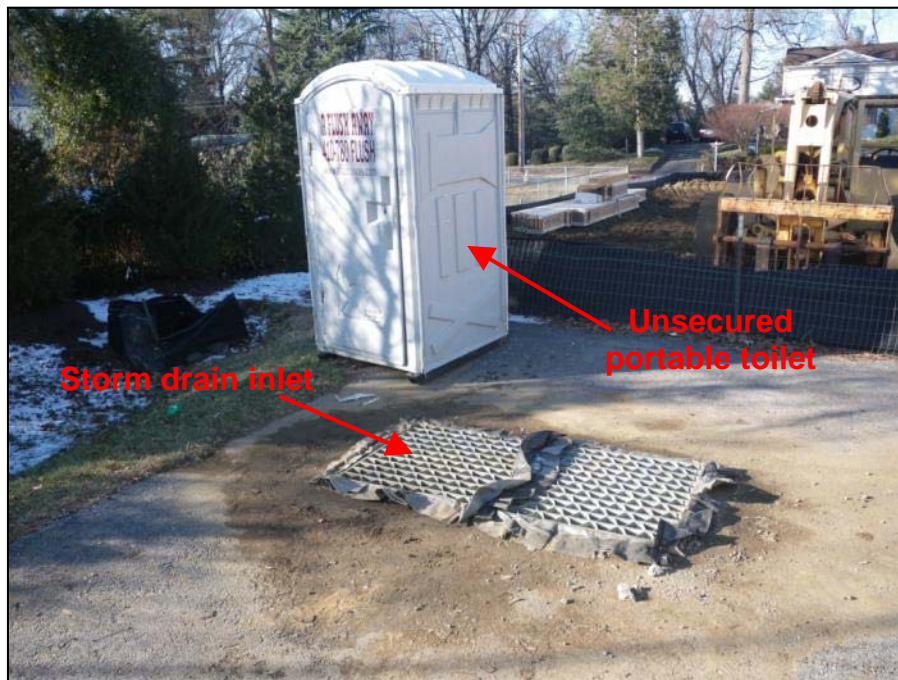
Photograph 22. View of unsecured portable toilet located in close proximity to the storm drain inlet.

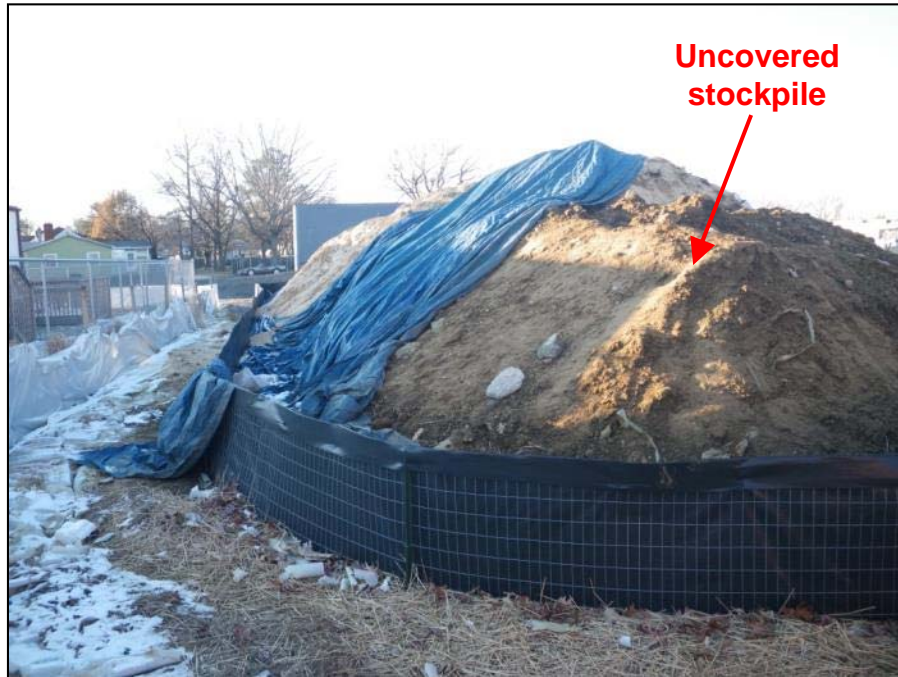
Photograph 24. View of uncovered soil stockpile in the southern portion of the site.

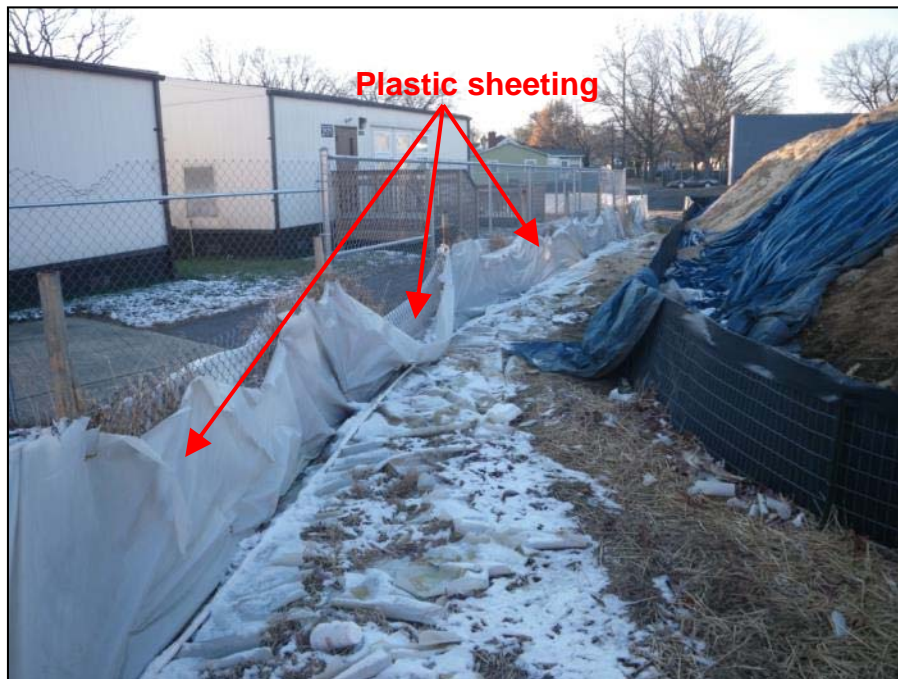
Photograph 25. View of plastic sheeting material used to prevent stormwater run-on from the adjacent property in the southern portion of the site. Note that the plastic sheeting material was deteriorated and pieces of the material were present on the ground surface.

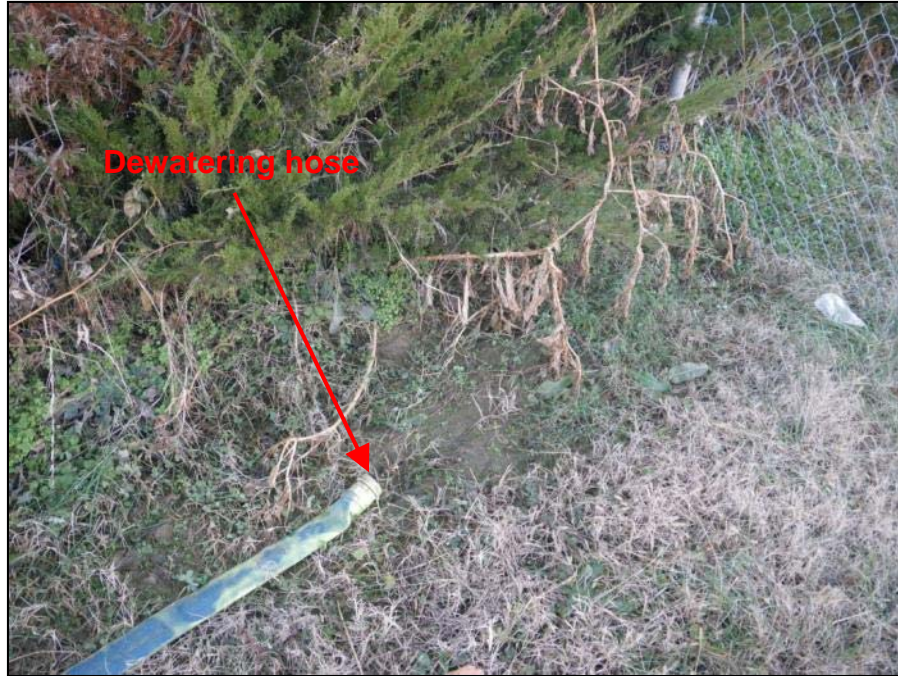
Photograph 30. View of end of hose used for dewatering from the generator room area. Note that a filter bag had not been used for recent dewatering activities.

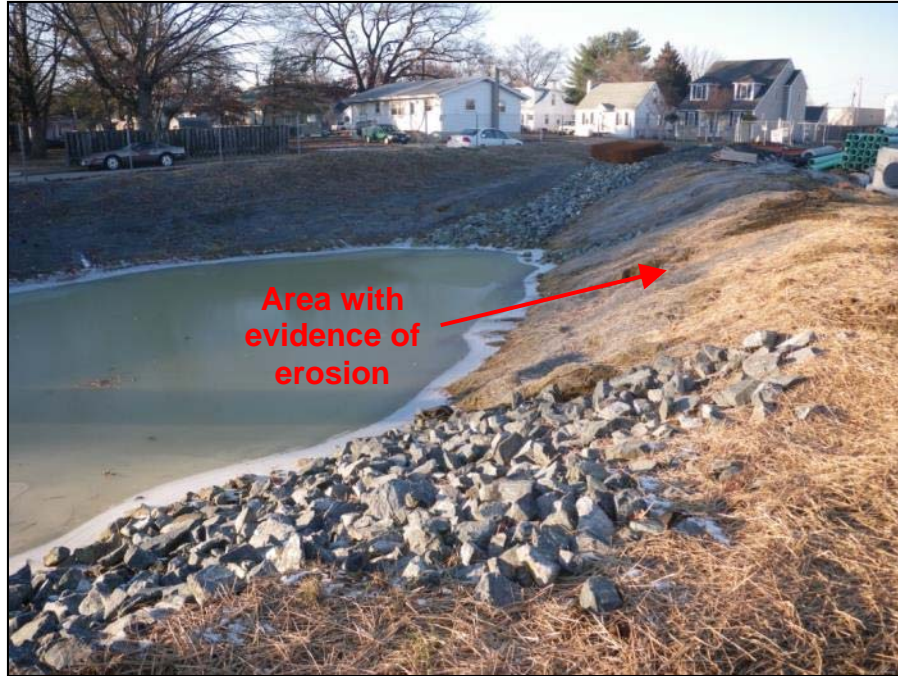
Photograph 32. View of area with evidence of erosion underneath erosion control matting installed on the slopes of the sedimentation basin.

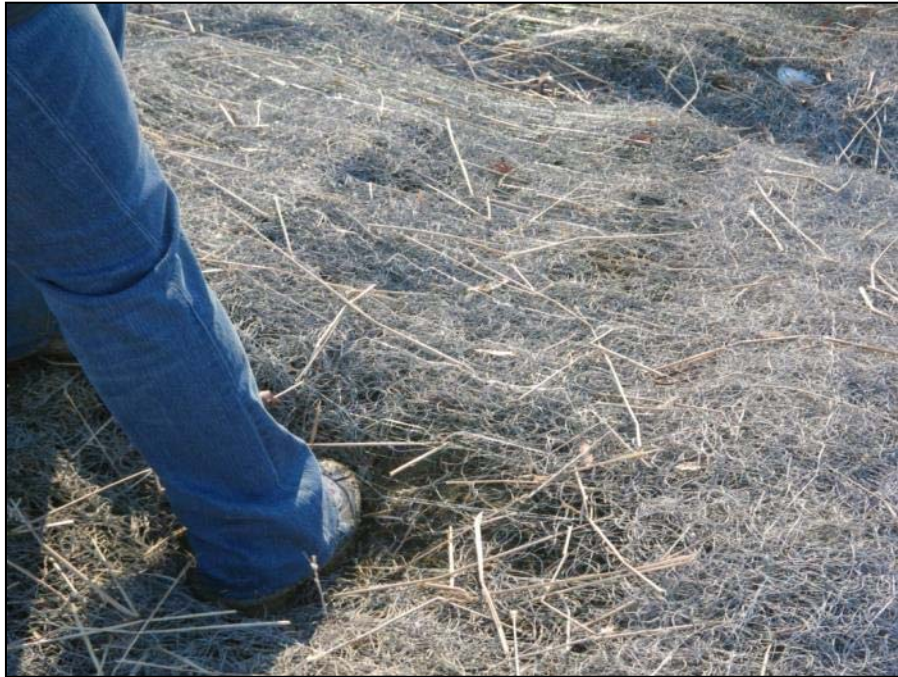
Photograph 33. Close-up view of eroded area underneath erosion control matting installed on the slopes of a sedimentation basin. Note that the inspector's foot was within an eroded area. Due to the presence of the erosion control matting, this feature is difficult to discern in the photograph.

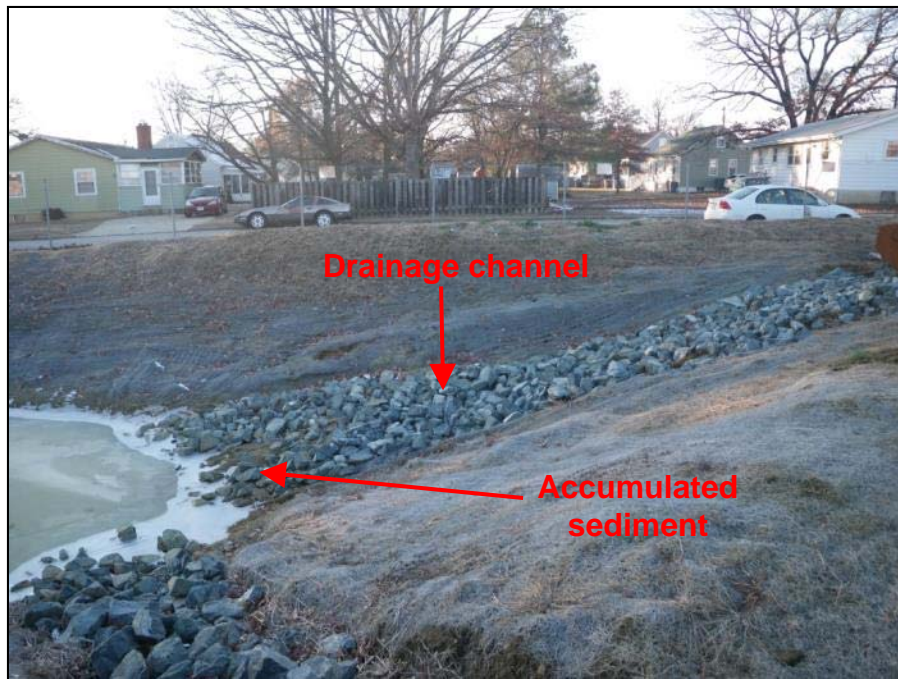
Photograph 35. View of accumulated sediment in the rock-lined drainage channel into the basin on its northern side.

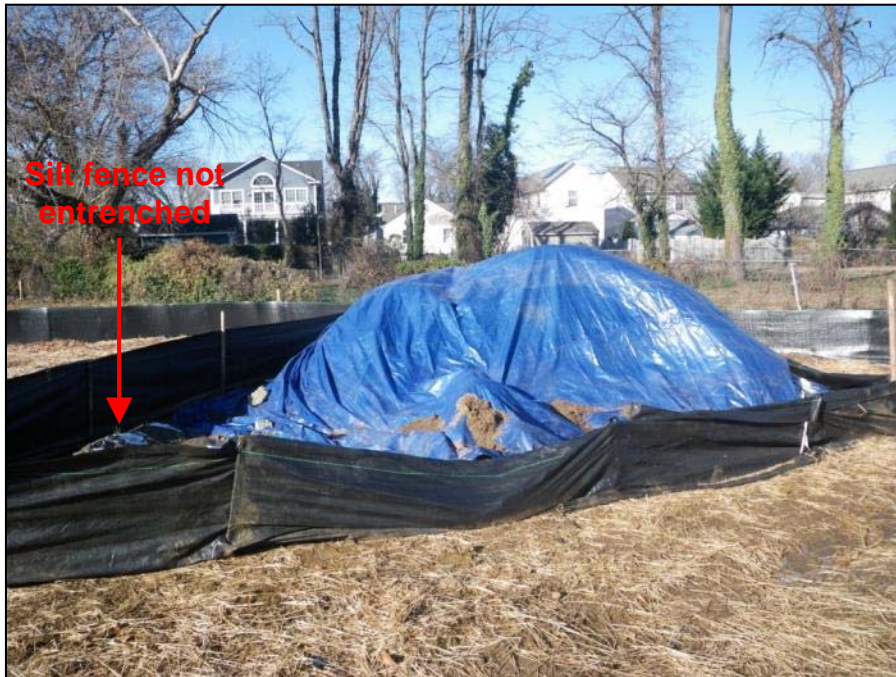
Photograph 42. View of silt fence around a soil stockpile at the site. Note that a section of the silt fence was not entrenched into the ground.

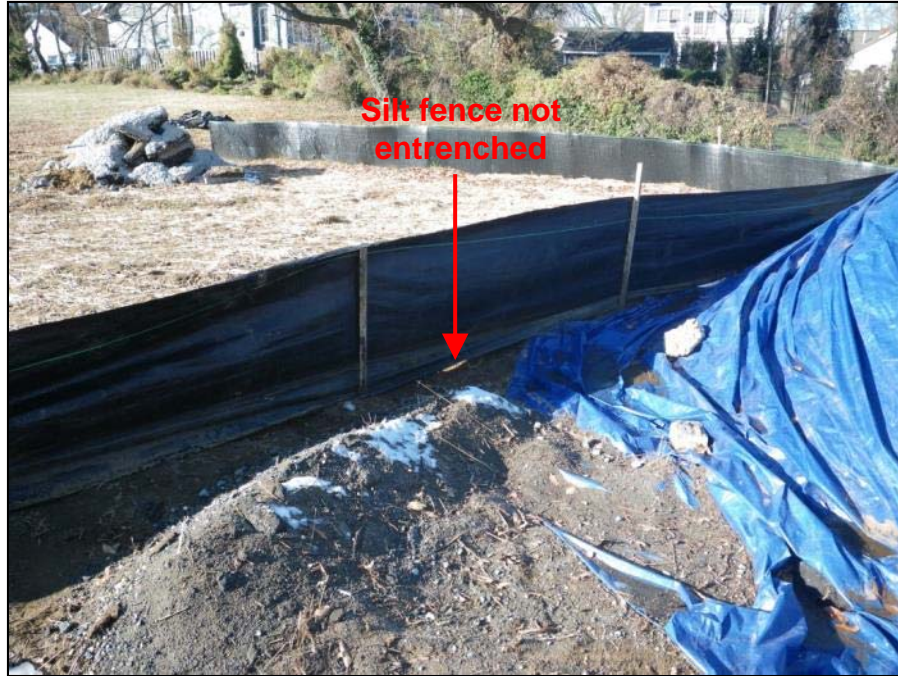
Photograph 43. Closer view of silt fence shown in previous photograph. Note that a section of the silt fence was not entrenched.

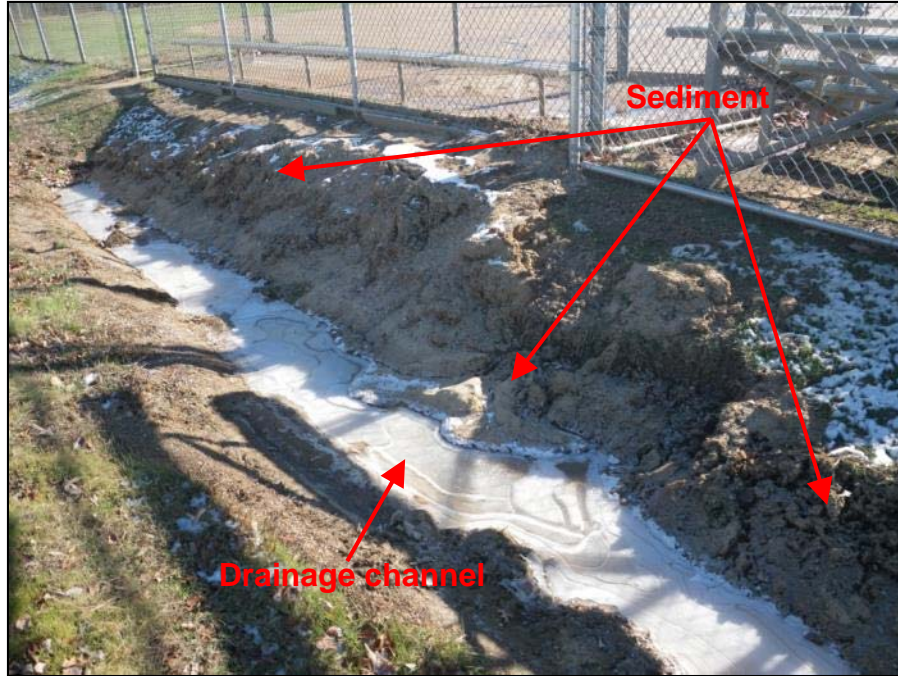
Photograph 53. View of drainage channel along the north side of the baseball field. Note that the channel had been disturbed and sediment was present in and around the channel, upgradient of one of the landscape infiltration basins.

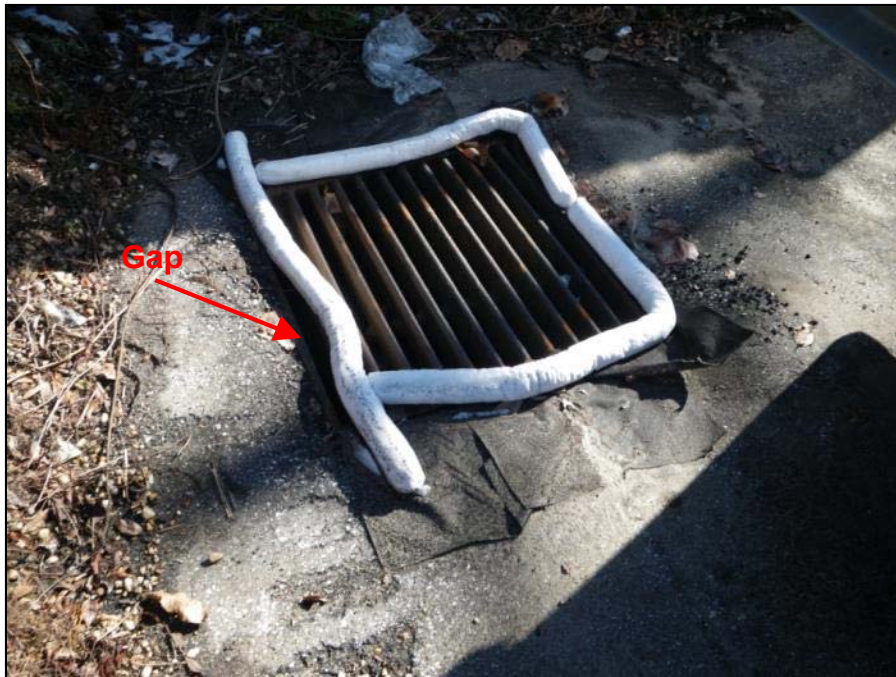
Photograph 65. 932 Spa Road – View of storm drain inlet located in the southeast corner of the facility. Note that the inlet protection BMP did not fully encompass the storm drain inlet grate.

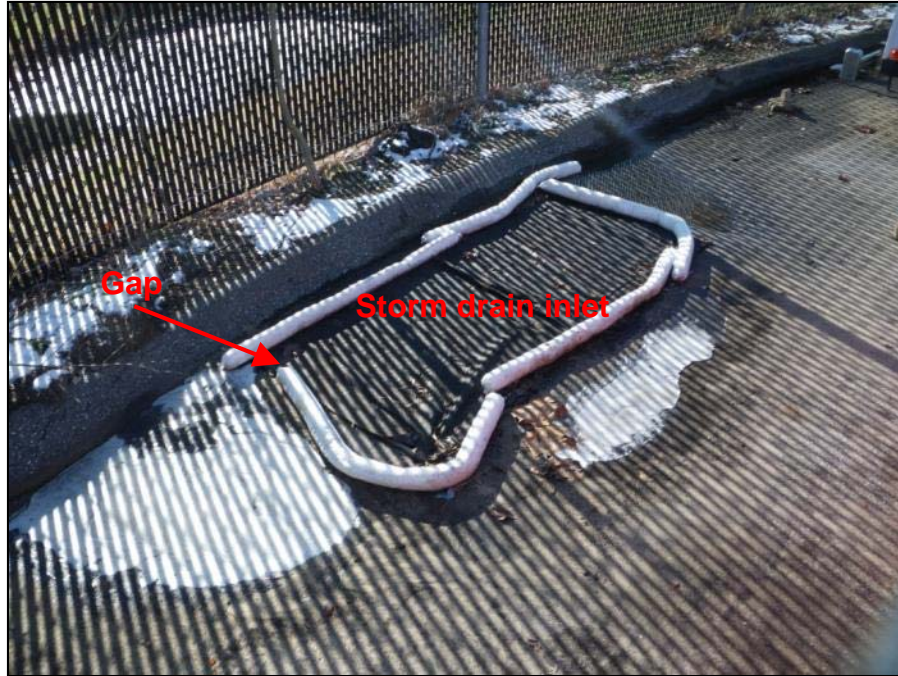
Photograph 66. 932 Spa Road – Additional example of inlet protection BMPs in the southeast corner of the facility that did not fully encompass the storm drain inlet grate.

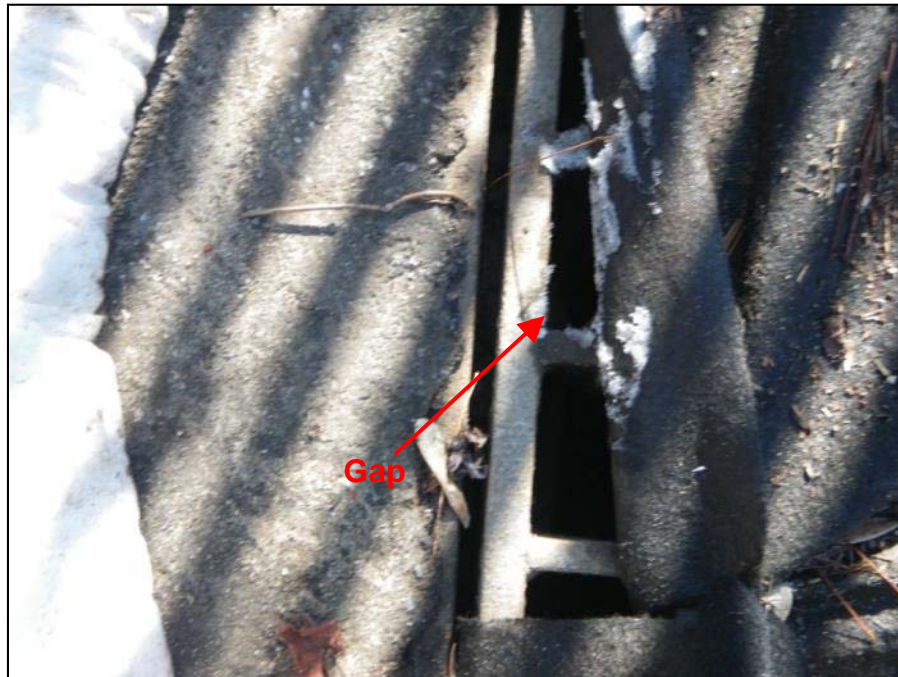
Photograph 67. 932 Spa Road – Close-up view of storm drain inlet grate which was not fully covered by filter fabric.

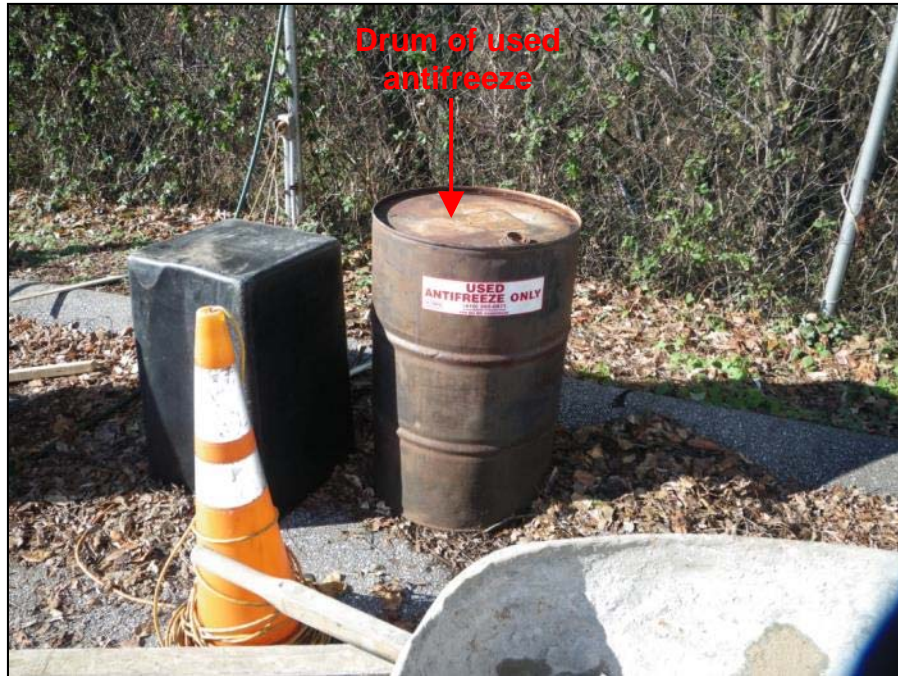
Photograph 68. 932 Spa Road – View of a 55-gallon drum containing used antifreeze stored outdoors and without coverage or containment.

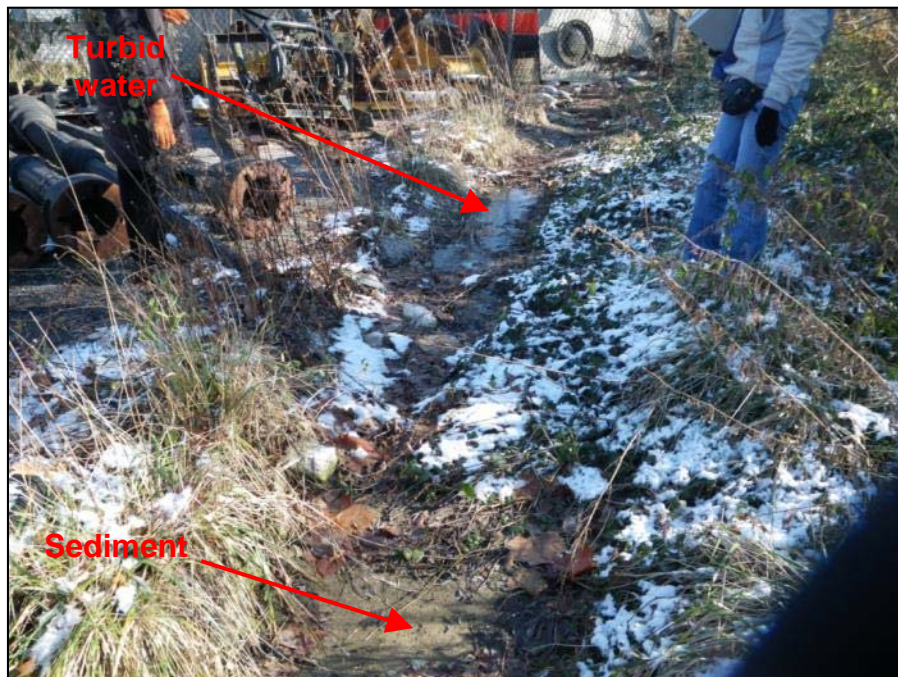
Photograph 69. 932 Spa Road – View of drainage swale containing sediment and turbid water downgradient of the facility's materials stockpile area, salt dome, and vehicle storage area.

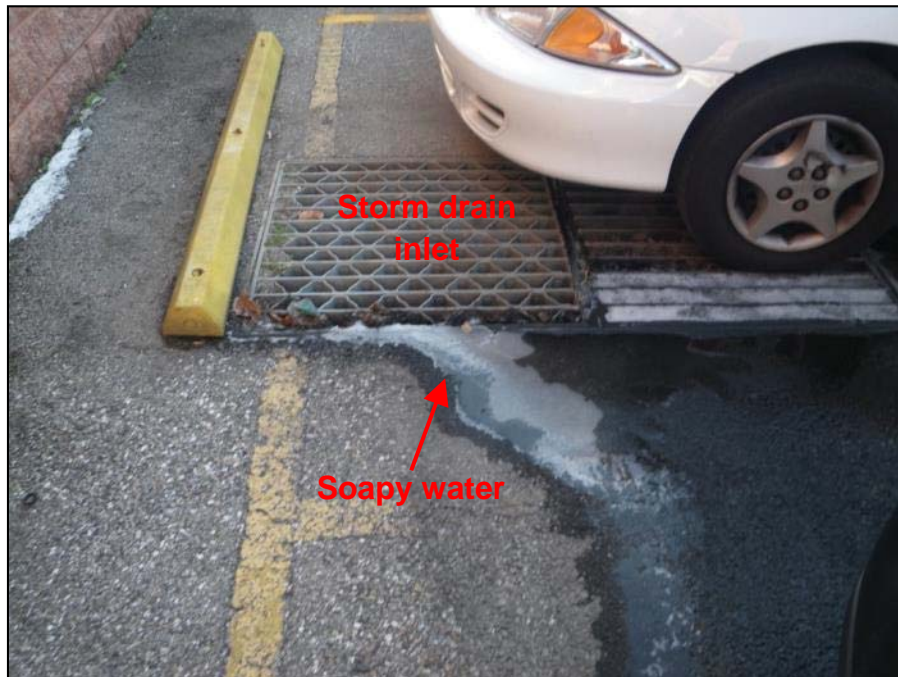
Photograph 76. View of the storm inlet drain located immediately to the west of the bus wash building. Note that soapy water from vehicle washing activities was entering the storm drain inlet.

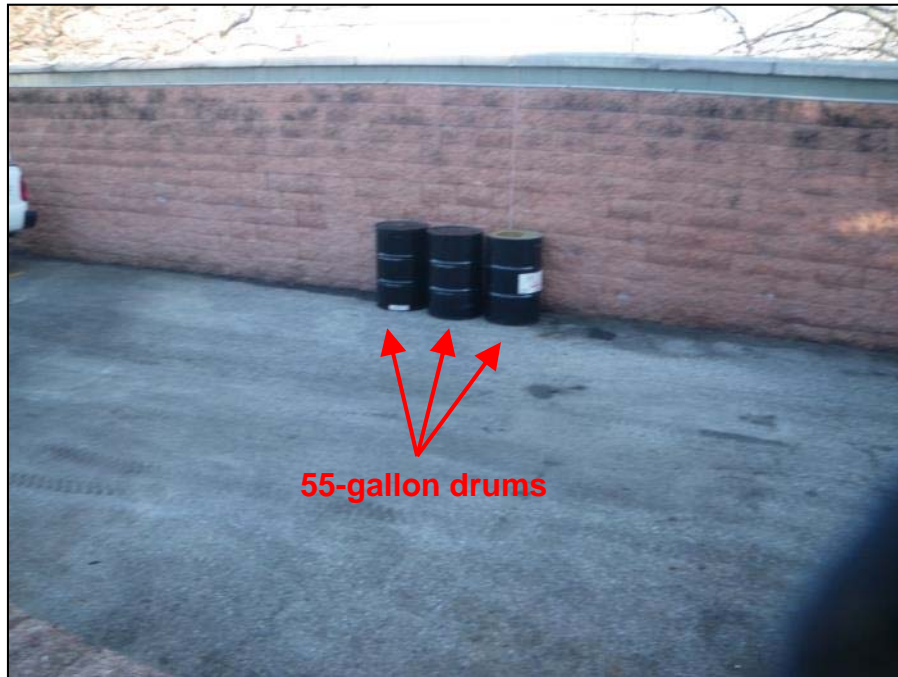
Photograph 78. View 55-gallon drums stored without coverage or containment to the east of the bus maintenance building. Note that the drum on the left was stored upside down and the EPA Inspection Team observed evidence of material leaking from the drum.

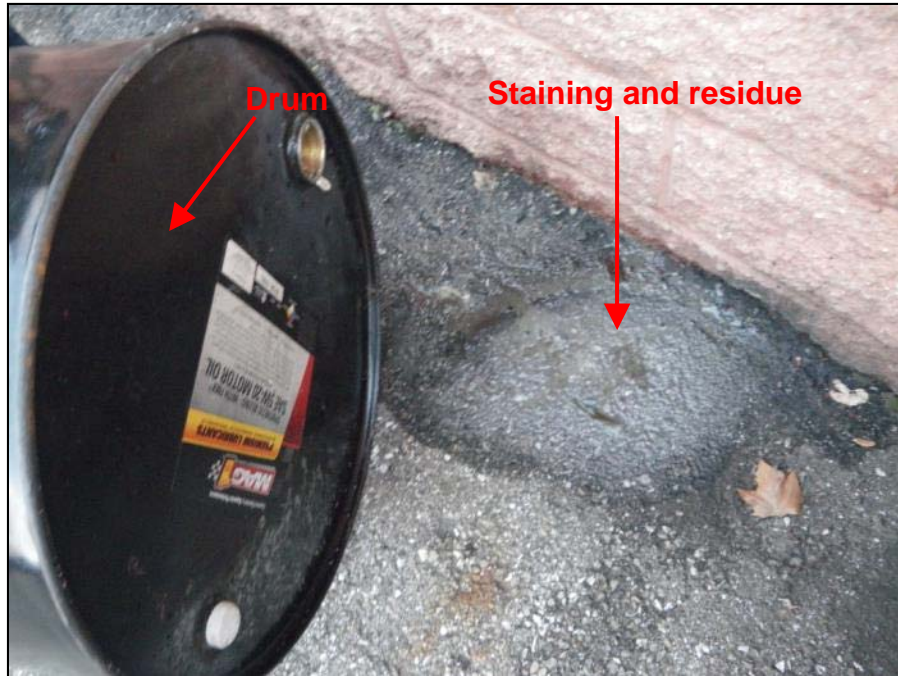
Photograph 79. Close-up view of 55-gallon drum on left in previous photograph. City staff moved the drum from its original position for staff to see what was underneath. Staining and residue was present in the area where the drum's bung cap was located.

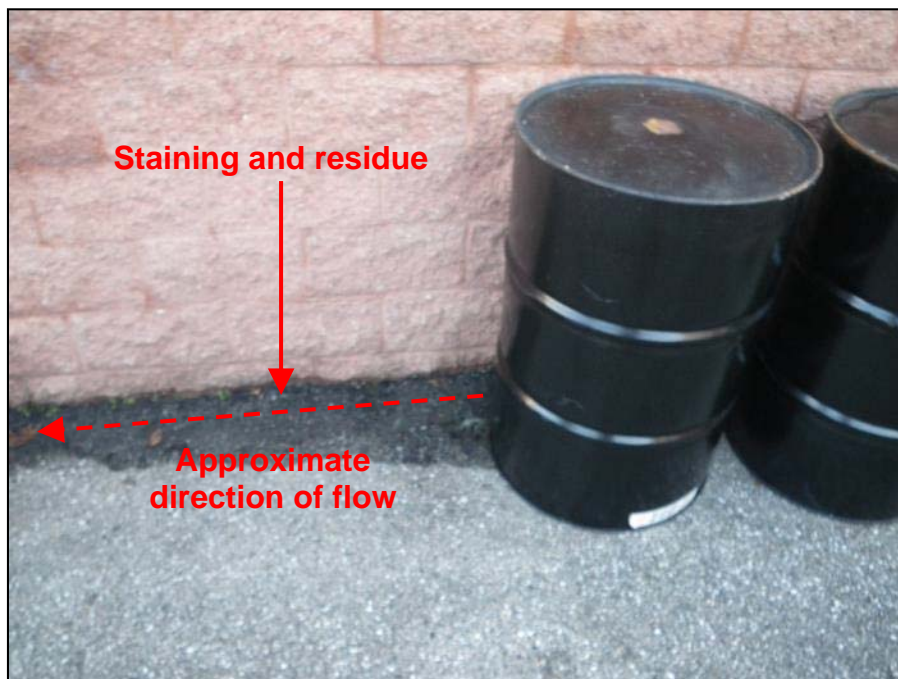
Photograph 80. Additional view of 55-gallon drums containing petroleum products without coverage or containment located to the east of the bus maintenance building. Note staining on ground surface and approximate direction of flow away from the drums.

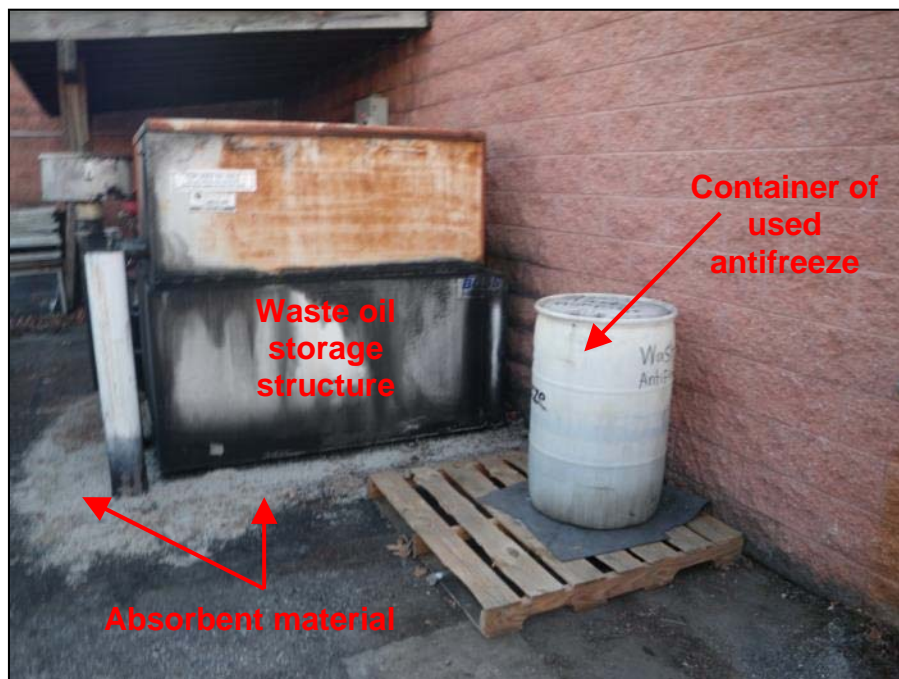
Photograph 84. View of container of used antifreeze stored outside and without coverage or containment in the waste oil disposal and storage area. Also note absorbent material on ground surface surrounding waste oil storage structure.
